Manhole Inspection Summary

Manhole # S35MM_054MH

Insp Date: **3/5/07 1:11 PM**

Location Address: **2000 BARCLAY ST**

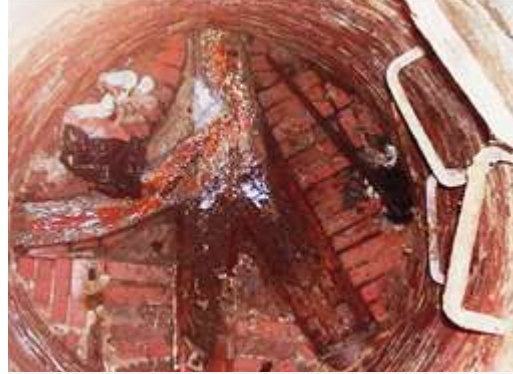
Top View

Evidence of surcharge - Bench debris.
Channel debris. Corroded steps.

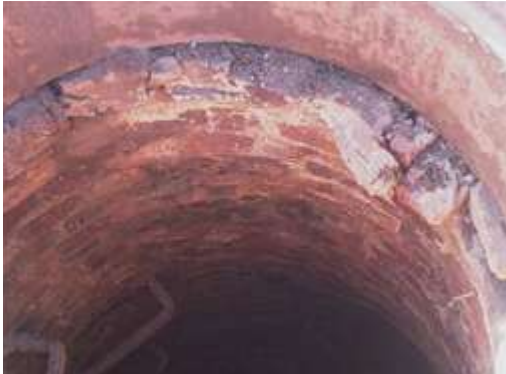
Defect

Frame leaks. Frame offset. Adjustment
deterioration, loose brick and infiltration.
Barrel infiltration.

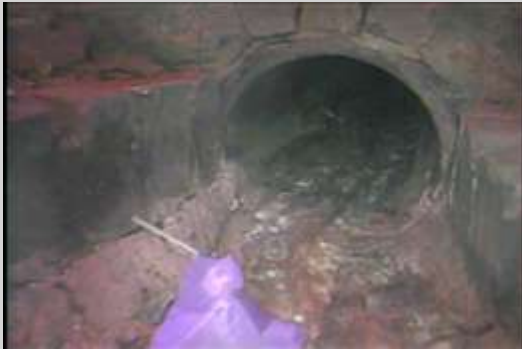
8 in. Circular Gravity Sewer Pipe Out @ 12 O'Clock

Infiltration: **Evidence** Pipe Seal Cond: **Unknown**

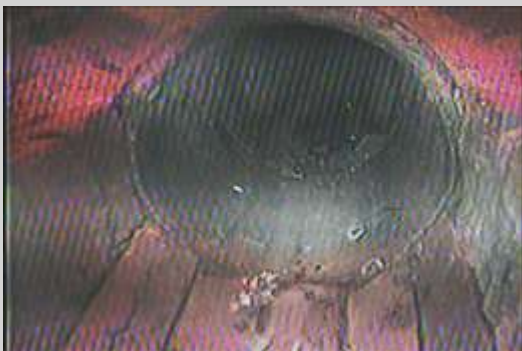
8 in. Circular Gravity Sewer Pipe In @ 5 O'Clock

Channel deterioration.

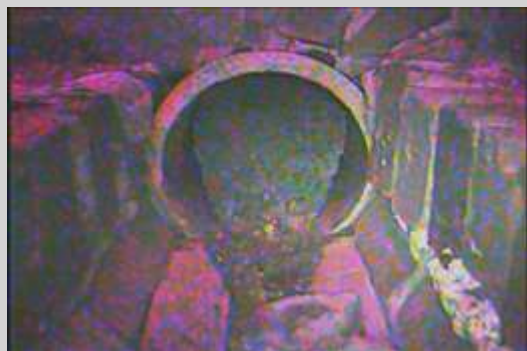
6 in. Circular Gravity Sewer

Deposits: ☐ None ☒ **Mud** ☐ Sludge ☒ **Debris** ☐ Grease

Silt Depth: **4** (in.) Deposits Extent: **Heavy**

Infiltration: **None** Pipe Seal Cond: **Broken**

Connects To: **Stub connection / abandoned**
